Subject: Rear Tailplane suspension

Effectivity: Glider MÜ 13 E "Bergfalke"
Bergfalke II
Bergfalke II-55
Bergfalke III
Bergfalke IV } all serial numbers

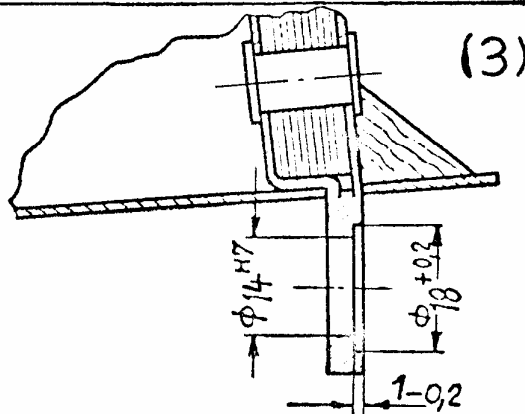
DETAIL A (WITHOUT BOLT)

Reason: Due to flight operations during many years, especially by many take-offs and landings (for instance training), on rough airfields both rear tailplane suspensions might be worn out.

1. Remove the elevator from the tailplane.
2. Machine both rear suspensions according to sketch 3:
 - a) with a tap drill $18 \phi + 0,2$ and $1 - 0,2$ deep.
In the case of a distance "measure a" (see sketch 1) tap drilling is not necessary or may be less deep than 1 mm.
 - b) with a twist drill enlarge the $\phi 12$ bore to $\phi 13,5$ and broach it up to $\phi 14$ H7.
3. Preserve the holes and the outer surface of the bushings with the primer LC 30-6101 Fa. BASF (or similar to that). Assemble and rivet the parts together according to sketch 4.
4. Measure the diameter (new 12ϕ) of the suspension studs (see sketch 1) and broach riveted bushings according to the measure of the stud.
5. Assemble the tailplane and mount it to the fuselage. Measure the deflection of the elevator and if necessary adjust.
