**Subject:** Main wing assembly (fittings with main wing centre pin).

**Effectivity:** Sailplane Bergfalke II } Instruction 1 all Serial numbers  
Sailplane Bergfalke II-55 } with one main wing centre pin  
Sailplane Bergfalke III } and on the ones where the safety  
Sailplane Bergfalke IV } pin hole is located under the  
top boom lug fitting.  
Instruction 2 all Serial numbers

**Reason:** Inspection of proper engagement of the main rigging pin in the main wing fittings

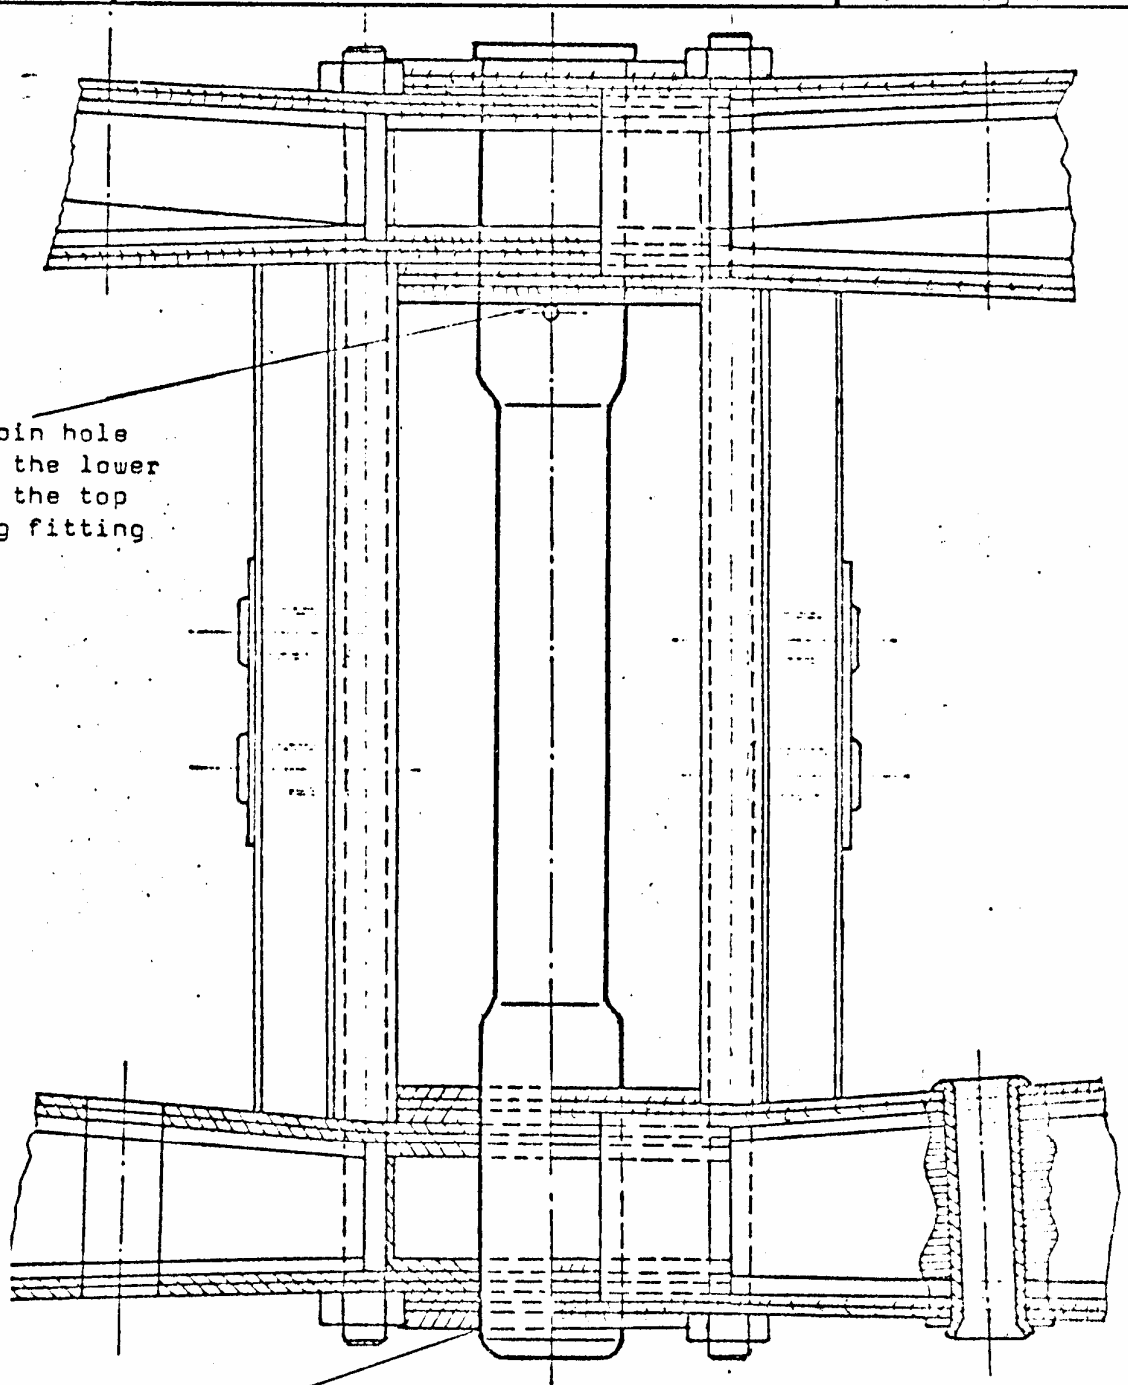
a) It must be checked that the main rigging pin is fully through the bottom lug fitting. With the main rigging pin pulled fully upwards by means of the tee handle, such that the 2,5 mm safety pin is hard against the lower face of the top boom lug fitting, inspect the amount of plain portion of main pin shank protruding below the port bottom boom lug fitting (Wings imburdened). If difficulty in the inspection is encountered when the Motorglider is assembled due to poor access, the wings must be removed and port wing inspected. Certainly upon the following assembly the inspection must be made again (when necessary, by help of a mirror and a handlamp).  
Should no plain shank be visible protruding below the port bottom lug fitting, according to a), the aircraft shall not fly until the cause has been established, and rectified. For that, contact the manufacturer Fa. Scheibe Flugzeugbau.

Safety pin hole  
against the lower  
face of the top  
boom lug fitting

Plain portion of the main  
rigging pin must protude below  
port bottom boom lug fitting
