Subject: Front tailplane fitting
Effectivity: Motorglider SF 25 all models, all serial numbers
Accomplishment: Before 31st of March 1982
Reason: The front tailplane fitting must be inspected for possible defects of fabrication in the welding seams.
Actions: 1. Dismount the tailplane from the fuselage

SCHEIBE FLUGZEUGBAU GMBH
Dachau, Aug. Pfaltz-Str. 23

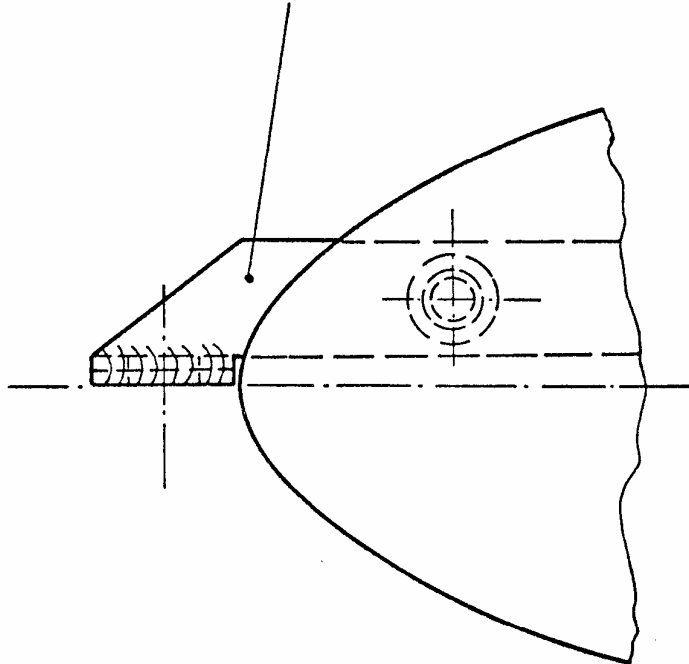
Front tailplane fitting

2. Remove the paint from the front tailplane fitting (see Sketch)
3. Inspect the fitting in the area of the welding seams for cracks by using a magnifying glass of at least 5 x power.
4. If cracks are found, then a new fitting must be mounted prior to the next flight. The defective fitting must be sent to the manufacturer (giving the total number of flight hours), with the request for a new fitting.

The new fitting is to be installed according to the Operational Instruction attached to this technical note.

5. If no cracks are found, the fitting is to be protected against corrosion with primer (for example Eintopf-Primer green LC 30-6101 from BASF), and the paint (in the colour of the motorglider).
